Stream Steward Campaign: Targeting Two Threatened Creeks in Chatham County

Division of Water Quality, North Carolina Department of Environment and Natural Resources
Section 319 US EPA Federal NPS Program

Catherine Deininger
Stream Steward Coordinator
Haw River Assembly
www.hawriver.org

October 31, 2009

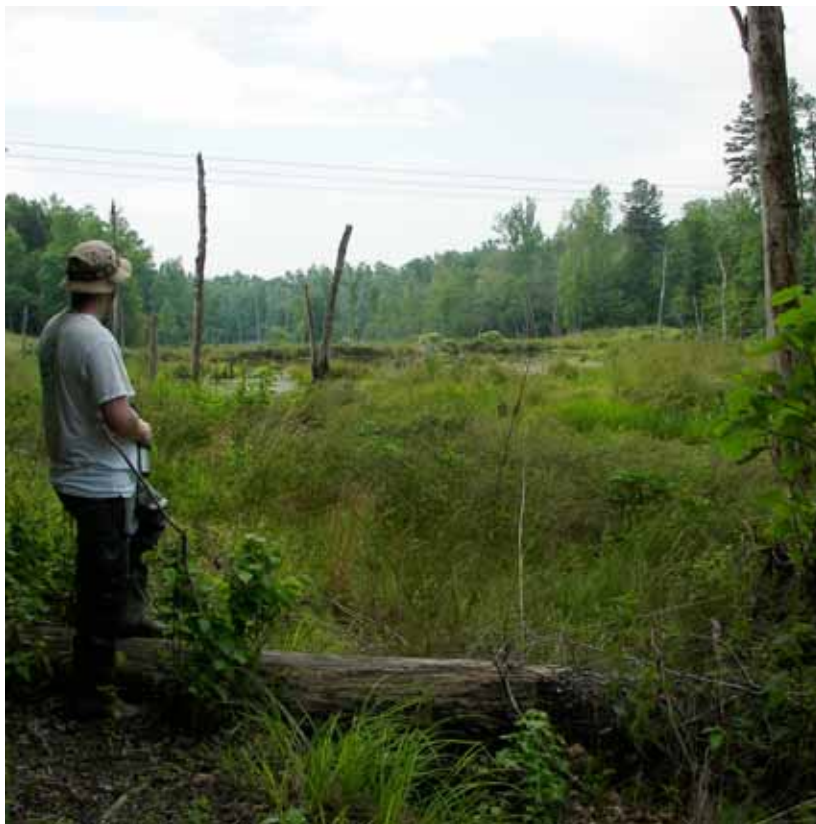
Neville Handel, HRA Volunteer surveys the Pokeberry Creek wetland at Briar Chapel

We discovered during our assessments that Pokeberry Creek is the home to numerous beavers that have helped create many large wetlands. These wetlands have done an excellent job at removing much of the sediment that has flowed into Pokeberry Creek from new development. Unfortunately many of the wetlands are filling in with muddy runoff. The stormwater sampling found that the turbidity in Pokeberry Creek is generally higher than it is in Dry Creek, but it also unexpectedly decreases as you go downstream, probably due to these wetland filters. Farms and

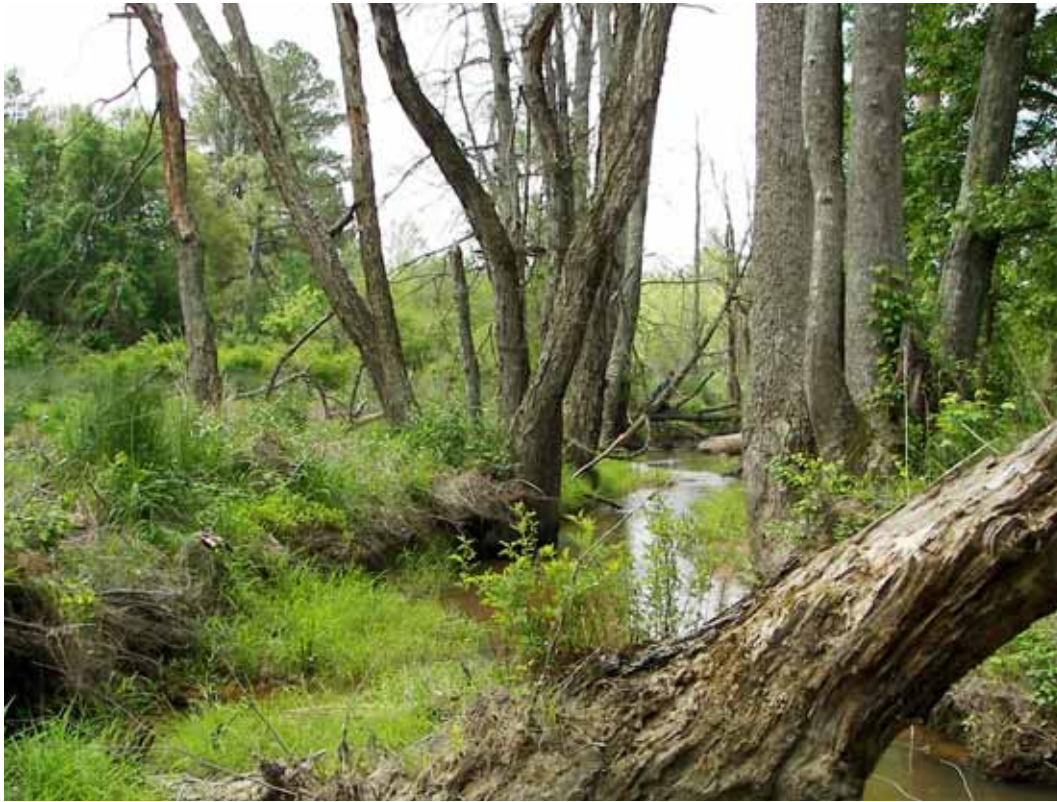
Monitoring site on Pokeberry Creek (Poke2). Downstream of Briar Chapel.

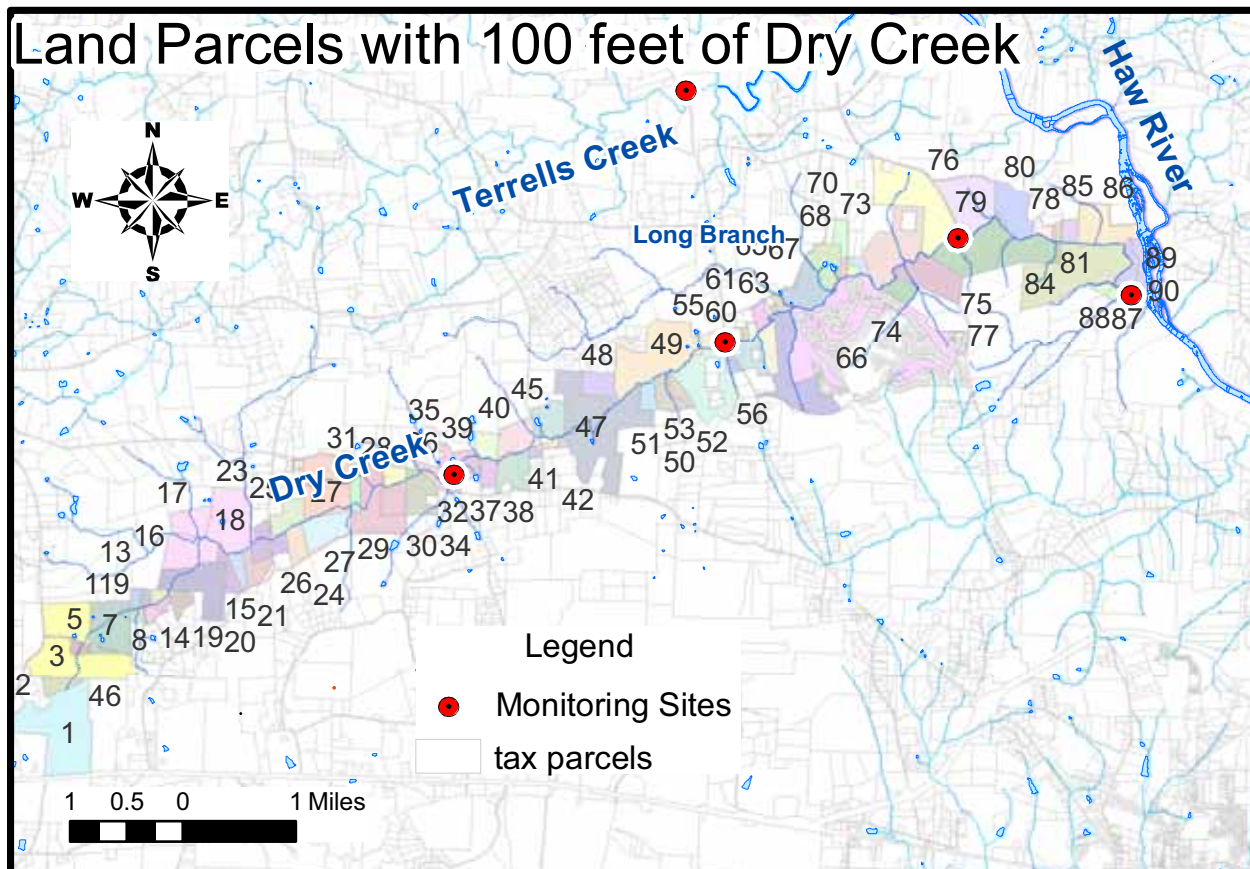
Figure 5. Monitoring Sites and Parcels within 100 feet of Dry Creek

Land parcels are colored so that adjacent parcels with the same landowner are the same color.

In March, HRA staff Catherine Deininger, walked approximately 11.3 of the 13 miles of Dry Creek and completed visual stream assessments for 63 reaches. Each assessment day she had another HRA staff member and/or volunteer with her to help. Getting to see Dry Creek expand from its headwaters to its confluence with the Haw was very helpful in the evaluation of the condition of the creek. After completing the GIS analysis on all the assessments conducted on Dry Creek, 61 letters were mailed to landowners containing the assessment scores for their section of Dry Creek. Along with the scores, each landowner was given specific recommendations on what they can do to protect Dry Creek and a copy of the HRA Stream Stewardship Handbook (handbooks are available for download from the HRA website www.hawriver.org under publications).

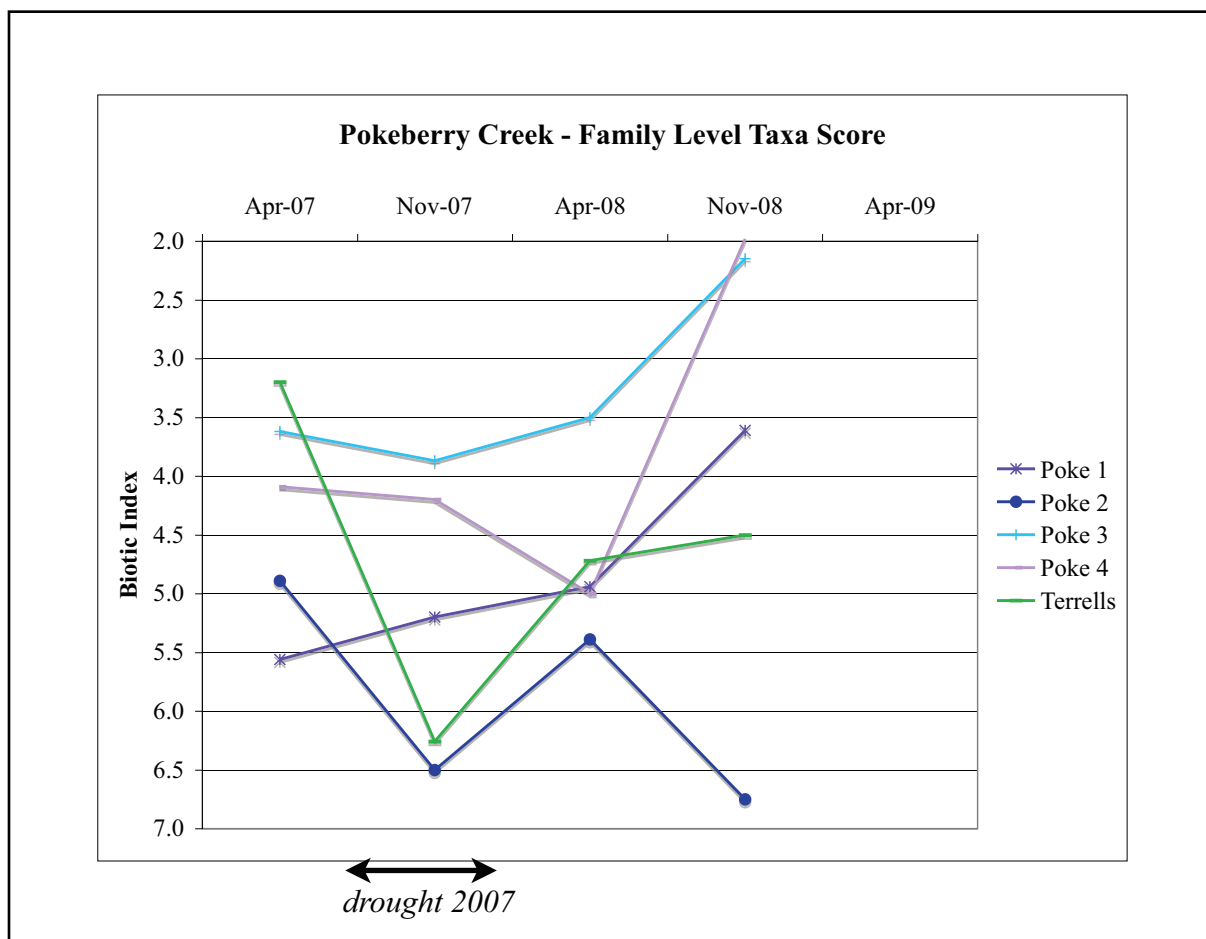
Figure 6. Total Taxa Biotic Index overtime for Pokeberry Creek

Note the y-axis on the graph is oriented such that lower water quality scores are lower on the graph.

- The Biotic Index Total Taxa (BI TT) scores for Pokeberry Creek ranged from 2.0 to 6.0 with a mean of 4.5.
- The BI TT scores appear to be improving over time except for Poke 2.
- The BI TT do not appear to be seasonally dependent except for Poke 2.
- The Poke 3 monitoring site which is located at the same site that DWQ monitors consistently had the best Biotic Index TT

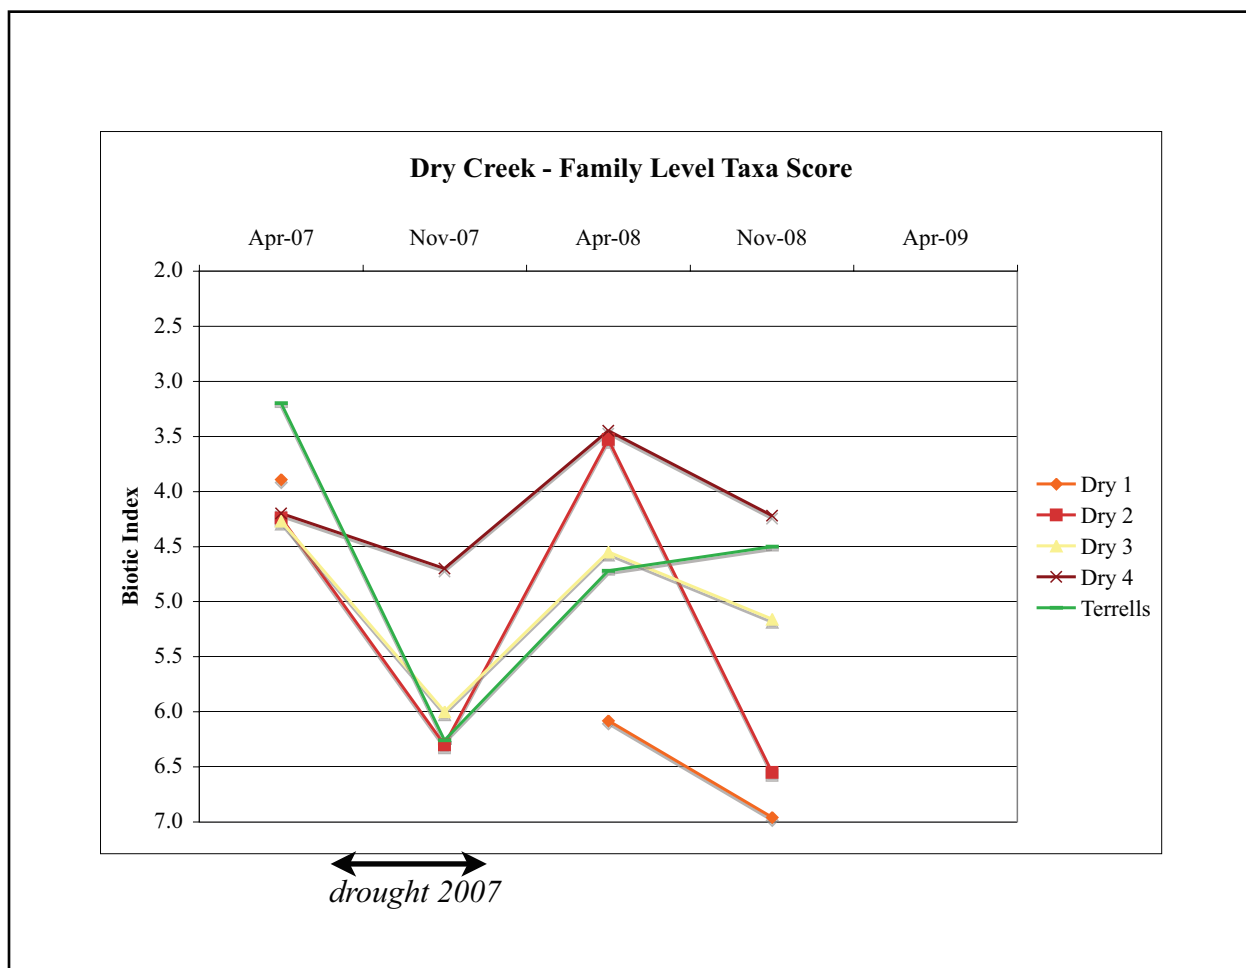
Figure 7. Total Taxa Biotic Index overtime for Pokeberry Creek

Dry Creek: During the drought all the monitoring sites on Dry Creek except for the most downstream site went dry. For the collection in November 2007, the sites on Dry Creek were wet but they were more a series of pools than a flowing stream except for the most the most upstream site on Dry Creek which was still completely dry. We were amazed though at the abundance of benthic macroinvertebrates we found in those pools. The macroinvertebrates found for this sampling period were dominated by facultative species such as dragonflies and aquatic beetles that can survive low oxygen situations.

- The BI TT range for Dry Creek was 3.5 to 7.0 with a mean of 4.9, similar to the range and mean obtained for Pokeberry Creek.
- The improvement of the BI TT in the spring and its decline in the fall indicate that tolerance level of the macroinvertebrate communities in Dry Creek are somewhat seasonally dependent.
- There appears to be a slight decline in the BI TT scores over time for Dry 1 and Dry 2. This could be due to the macroinvertebrate communities in these upstream sites still recovering from the drought.
- The BI TT scores appear to be improving over time at the downstream sites, Dry 3 and Dry 4.

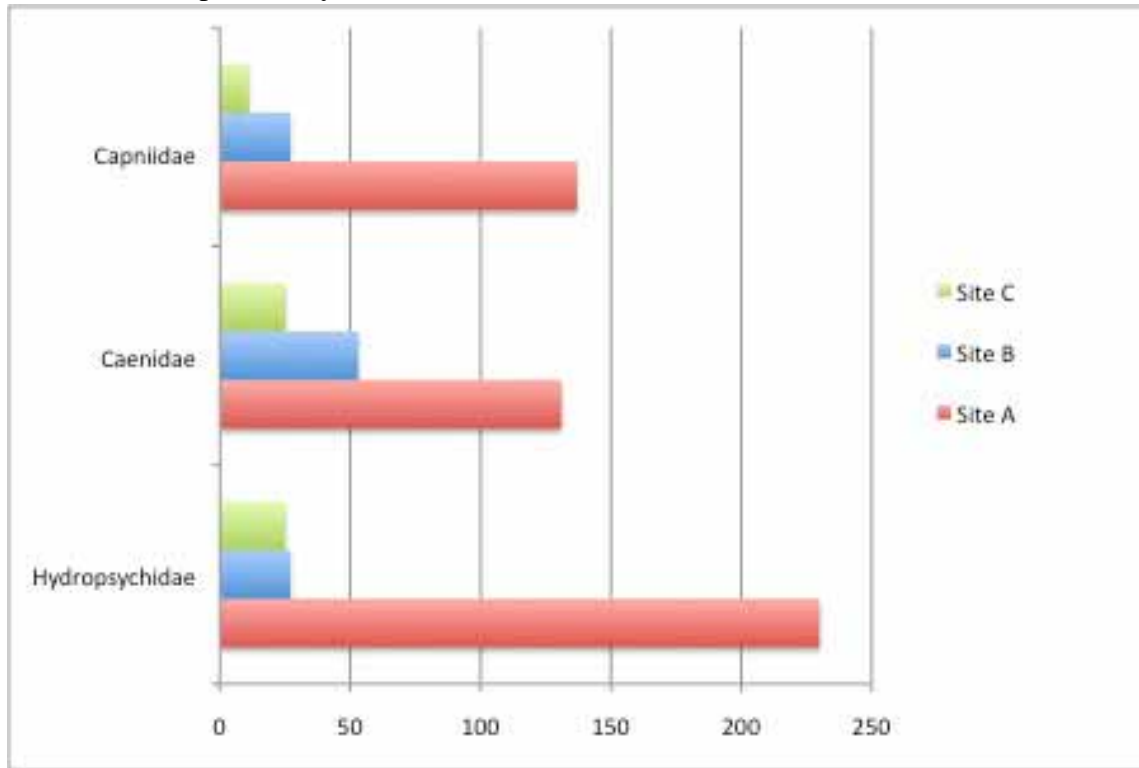
Figure 8. Insect abundance by sampling site, Terrell's Creek, November 2008

Terrells Creek Sampling Study: For this additional sampling study, we found the most abundant family from each order (Trichoptera, Ephemeroptera, Plecoptera) was independent of the sampling site. However, the location of the sampling site is shown to exhibit a strong influence on insect abundance, as shown in Figure 8. This indicates that even if factors such as season and flow level are not important, the current sampling procedure is not robust enough to provide

data for specific insect populations which is predictive, in a quantitative sense, with respect to stream water quality. By comparison, the overall richness scores show much less variability, indicating that this variable is likely to be a better predictor of stream health. Since diversity would be expected to decrease with a significant decrease in water quality, anomalous decreases in richness are potentially a cause for concern.

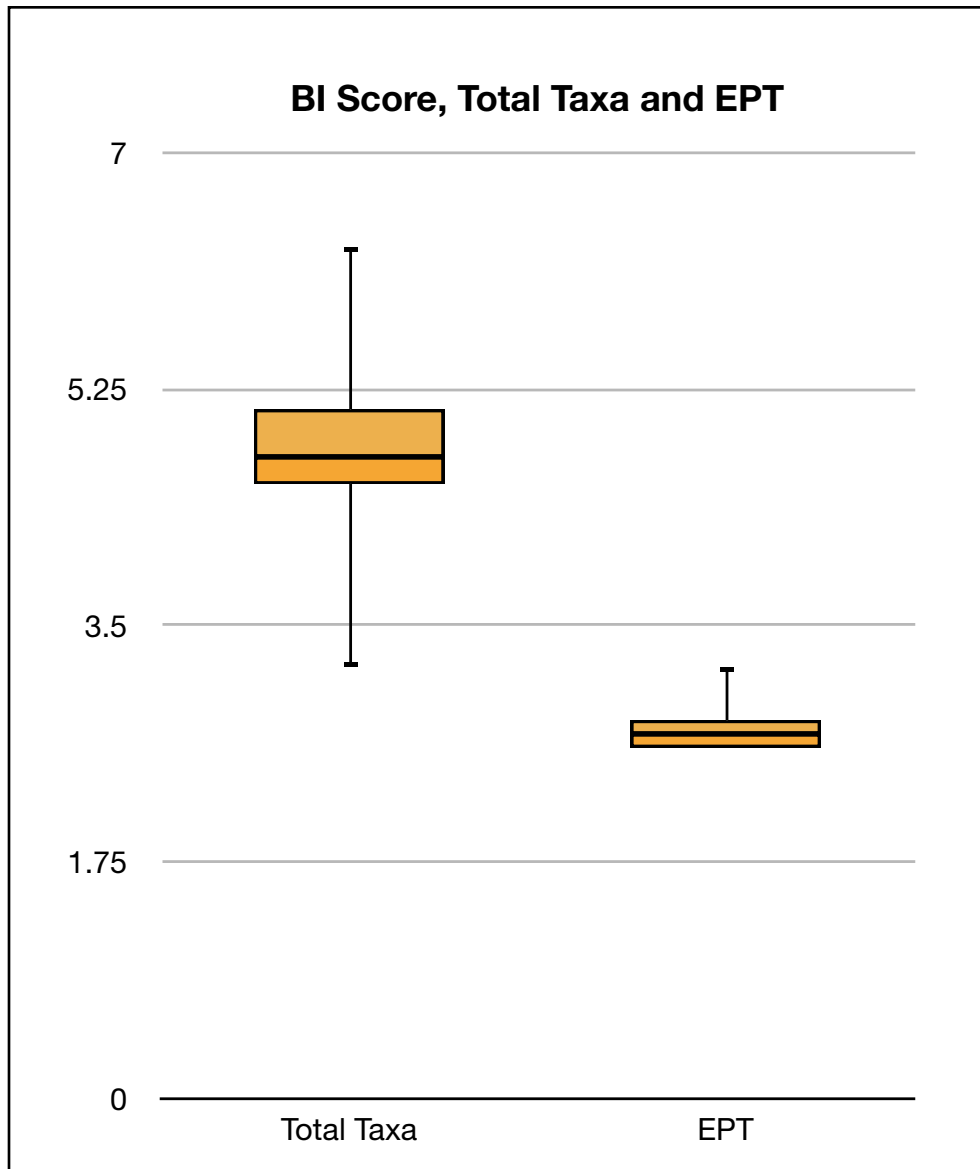
Figure 9. Box plot for Biotic Index Scores for all Terrells Creek samples

The box plot shown in Figure 9 shows the range of values obtained by applying the BI TT and BI EPT conventions to data obtained from Terrell's creek. While, each of the scoring conventions derives from the same set of data, the BI EPT Score demonstrates significantly less variability relative to the BI TT Score. The primary goal of the box plot is to provide a stream-specific, graphical basis to determine whether a particular data point is likely to be an outlier based on historical data. As sampling continues, this precision of this approach will increase accordingly. Outliers are expected to be associated with specific events, which may be either natural such as extreme drought or of anthropogenic origin.

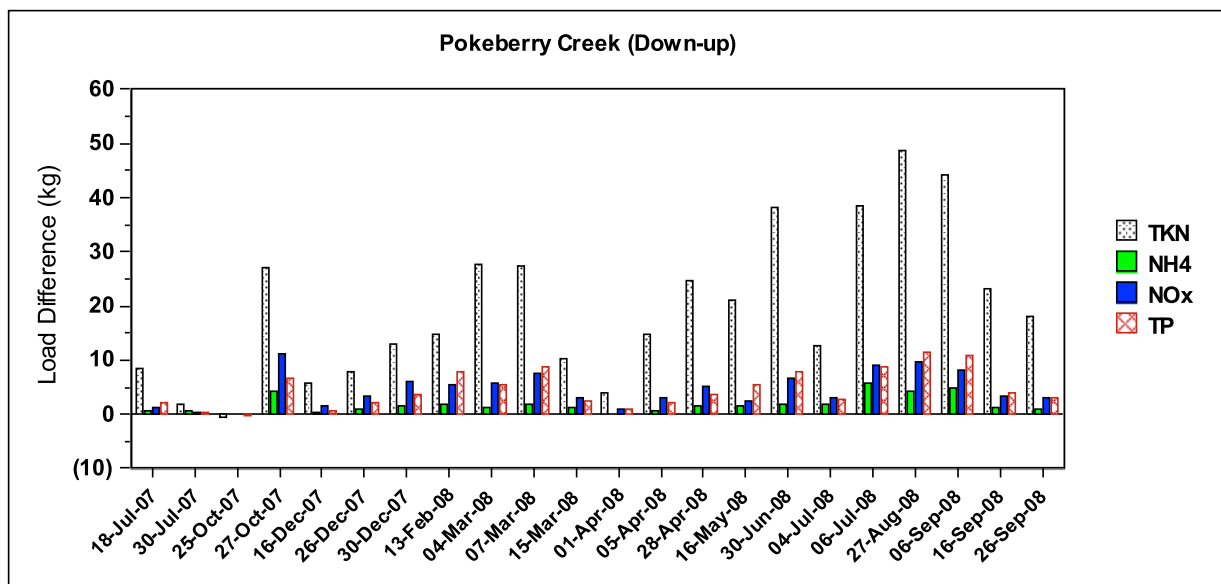
Figure 10. Differences in storm loads from upstream to downstream for Pokeberry Creek

Figure 10 contains the differences in loads for Pokeberry Creek, which shows that the storm event loads at Pokeberry were small only through October of 2007 indicating that Pokeberry Creek recovered quickly from the drought conditions.

- Mean concentrations of all the pollutants except organic nitrogen and turbidity were greater at the upstream sites
- Total Suspended Solids was skewed due to high concentration of coarse sediment in March 2008 which was the first heavy rainfall after the drought of 2007.
- Higher turbidity downstream may be due to smaller organic particles from flushing out of the wetlands
- Large areas of wetlands may be acting as filters for nitrogen, phosphorus, and sediment.
- Mean concentrations for all pollutants except nitrate+nitrite nitrogen were similar between Dry and Pokeberry Creek.
- The mean turbidity levels in both Pokeberry sites were greater than the state standard for most receiving waters (50 NTU).
- No statistical difference in storm event loads between upstream and downstream sites.

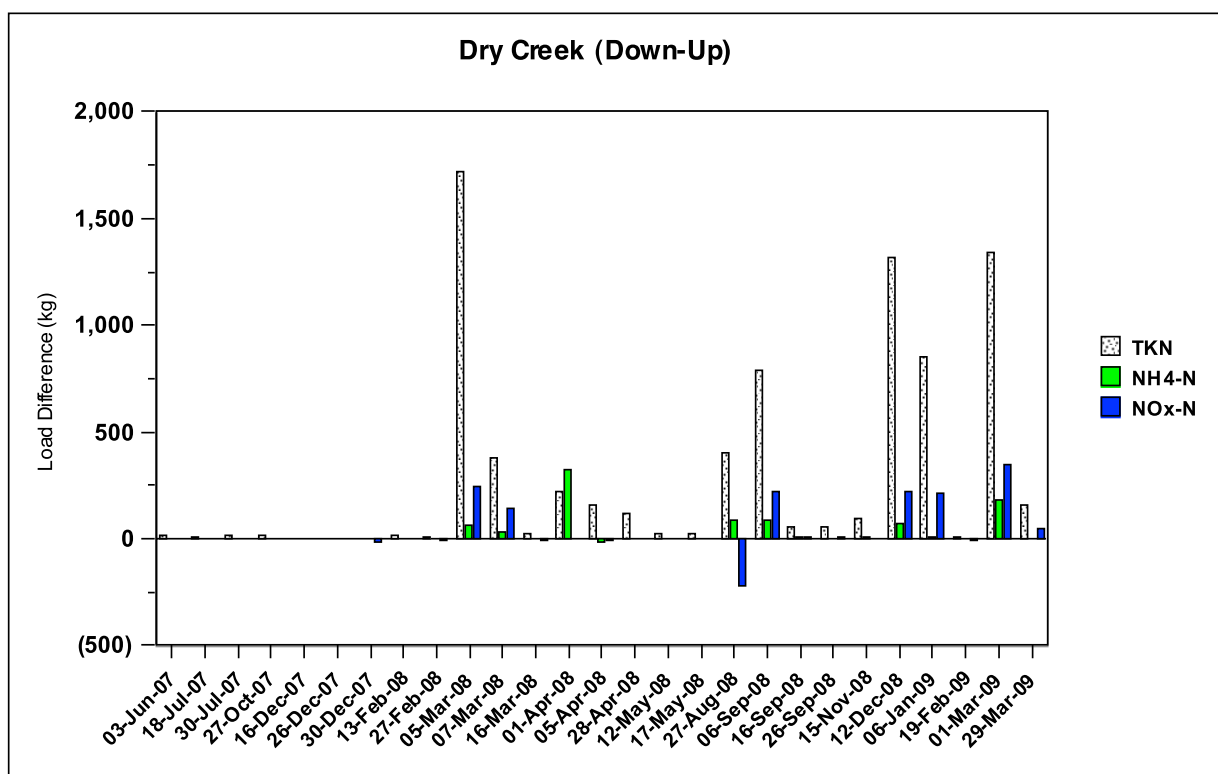
Figure 11. Differences in storm loads from upstream to downstream for Dry Creek.

Figure 11 contains the differences in loads for Dry Creek, which shows that the storm event loads relatively small until the spring of 2008 indicating lingering effects of the drought of 2007.

- Discharge and pollutant movements in Dry Creek are storm event driven.
- Just like Pokeberry TSS decreased from upstream to downstream while Turbidity increased (difference was less than at Pokeberry).
- Mean ammonium nitrogen concentration was greater at the downstream site which may indicate organic waste.
- Mean phosphorus concentrations stayed the same between sites.
- Mean concentrations of other pollutants (TKN, NO_x-N, TN) decreased from upstream to downstream.
- Approximately half of the mean turbidity levels at both Dry Creek sites were greater than the state standard for most receiving waters (50 NTU).

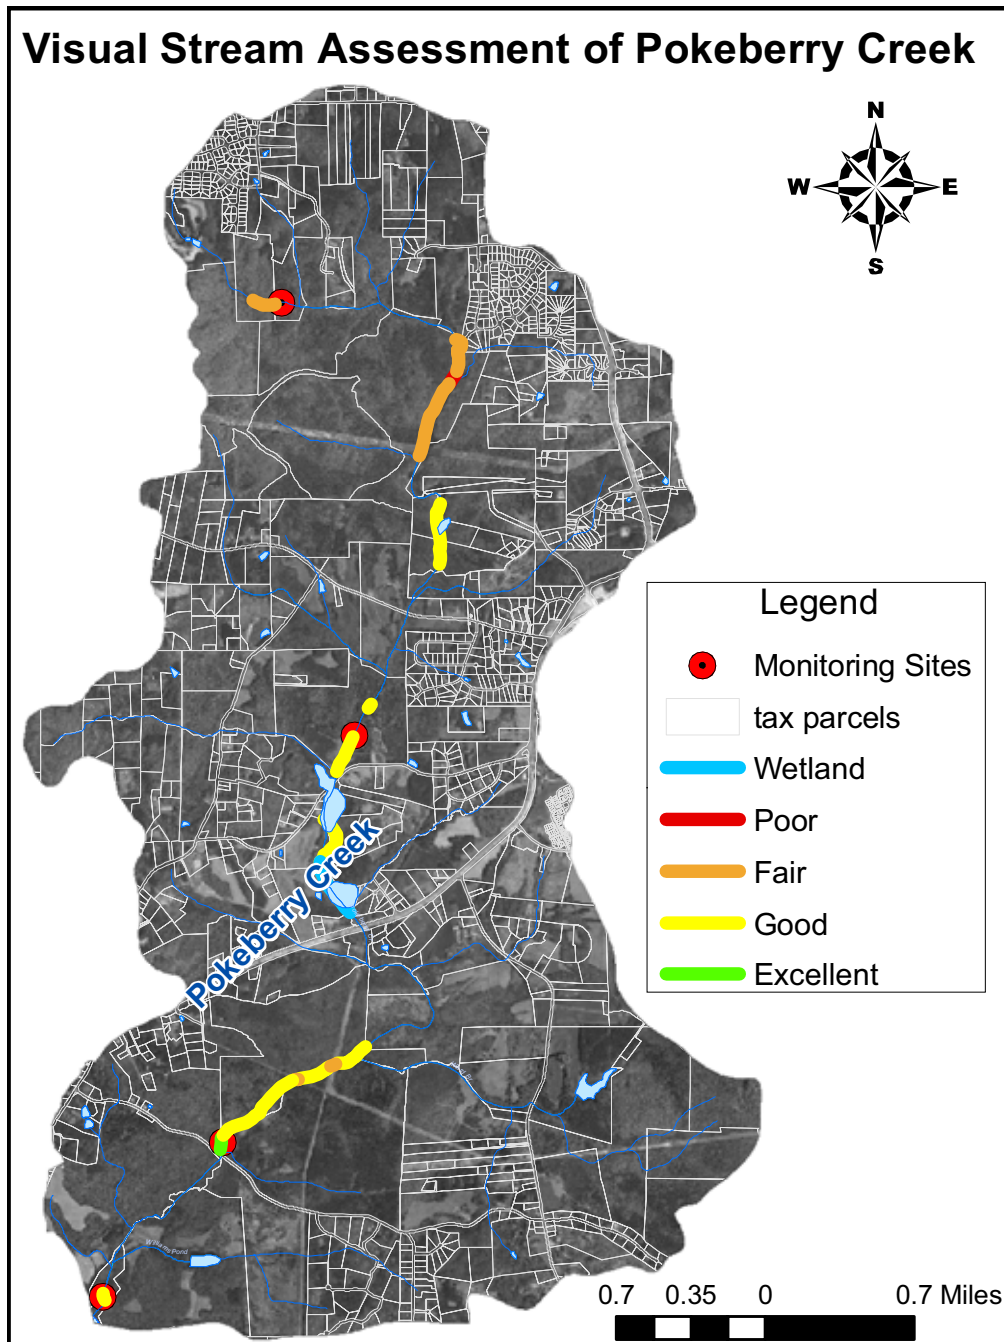
Figure 12. Scores for Visual Assessments along Pokeberry Creek

From upstream of Briar Chapel Subdivision to Highway 15-501, Pokeberry Creek flows through a string of wetlands and beaver ponds. Pokeberry Creek has a defined channel though most of these wetlands, but where it disappeared completely, we were not able to score the wetland using the NRCS SVAP. The wetlands and beaver ponds are creating amazing undisturbed wildlife

habitat in this primarily residential watershed. Many of the potential conservation easements identified during the assessment are to protect these wetlands. At the beginning of 2008, Chatham County passed a new buffer ordinance that requires 50 foot buffers on wetlands and linear wetlands for new development. Several of the wetland areas identified for conservation along Pokeberry Creek are still undeveloped, so those areas will be provided some protection by the new buffer rules, if they are eventually developed.

- ii. Looking at the average scores, *Water Appearance* and *Riffle Embeddedness* had the lowest averages reflecting the high level of sediment in Pokeberry Creek which is causing the water appearance to be cloudy and filling in the riffles.
- iii. The overall average score was *Good* (8.0)
- Potential BMP and Conservation sites along Pokeberry Creek
 - i. 13 Recommended areas for conservation easements
 - ii. 2 Riparian buffer plantings
 - iii. Streambank stabilization at Briar Chapel Parkway bridge over Pokeberry Creek wetland
 - iv. Stormwater BMPs (bioretention, level spreaders) along Pokeberry Creek wetland within Briar Chapel to protect wetland from runoff from spray irrigation and muddy runoff from power cut.
 - v. 2 Stabilization of 2 stream crossings by gas line and power cuts

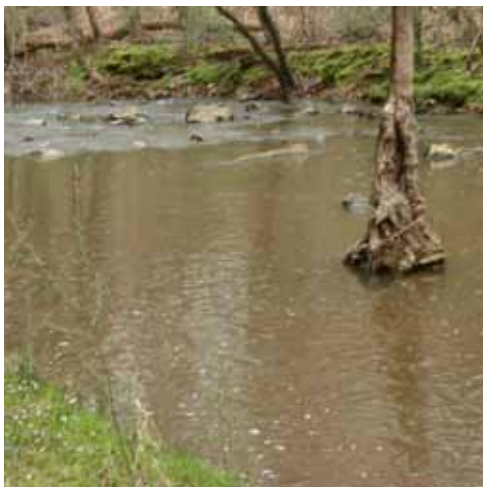
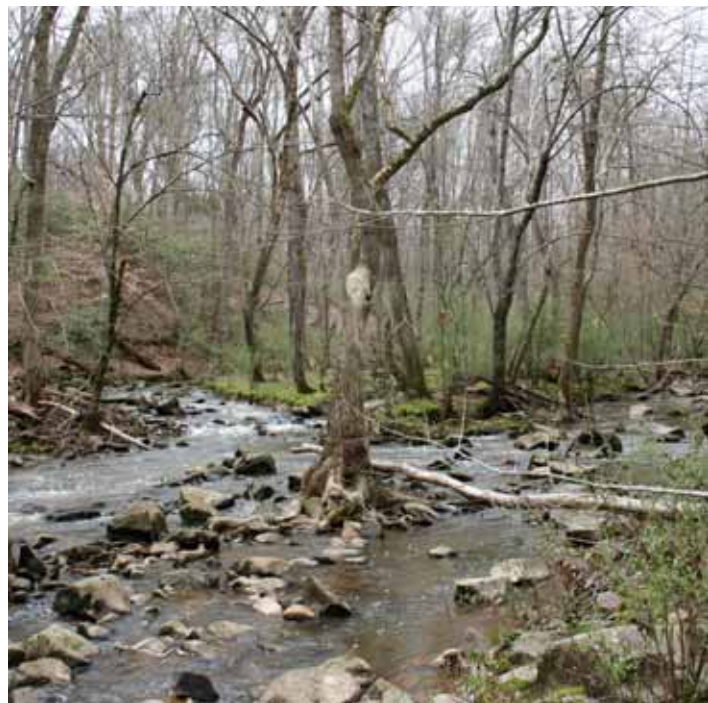
Dry Creek Assessments: Streambank and channel erosion were continually noted during the assessment of Dry Creek. Bank stability was scored low in all but a couple of the reaches due to either an incised or an actively widening stream channel. Upstream of Highway 87 the stream channel is often incised 6 to 8 feet deep. After crossing Highway 87 the stream channel begins to contain more bedrock and the channel starts to erode more horizontally than vertically. After Old Graham Road the stream channel is primarily bedrock and large cobble. The stream channel becomes wide and often breaks up into braided channels.

Trees stranded in the middle of Dry Creek due to eroding streambanks and widening stream channel.

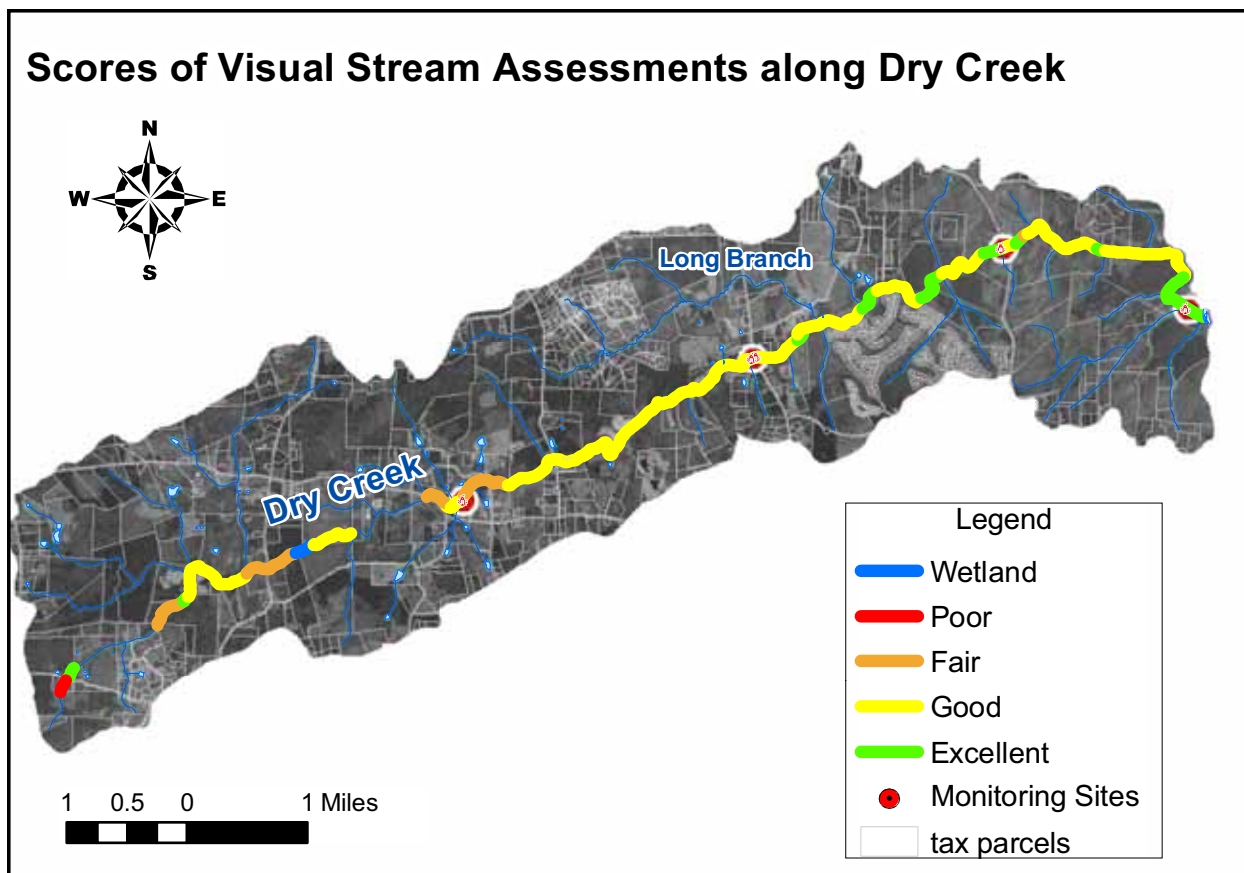
Figure 13. Mapped Scores for Visual Assessments along Dry Creek

Primarily the *Excellent* scores for Dry Creek were downstream of Old Goldston Road where Dry Creek flows through the Rock Rest community before emptying into the Haw River. 8 of 9 recommendations for conservation easements along Dry Creek were made for this section.

- ii. 16 Riparian buffer plantings (scored less than 3 on Riparian Zone in visual assessment or noted during assessment that planting would be useful)

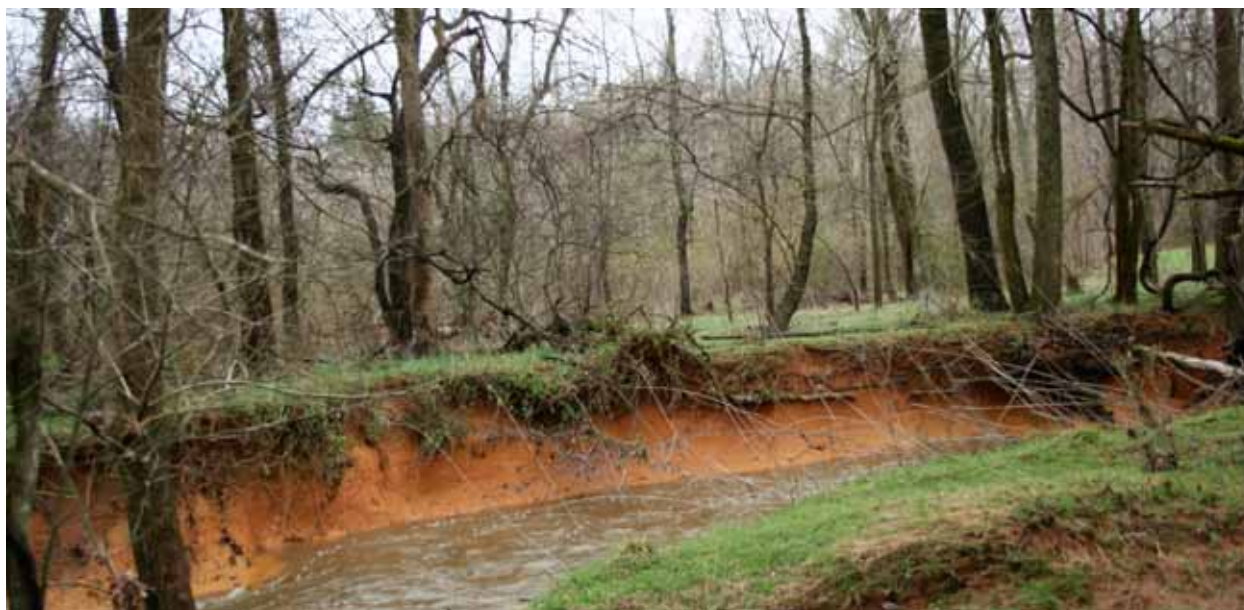
Eroded streambanks and incised stream channels were frequently seen along Dry Creek.

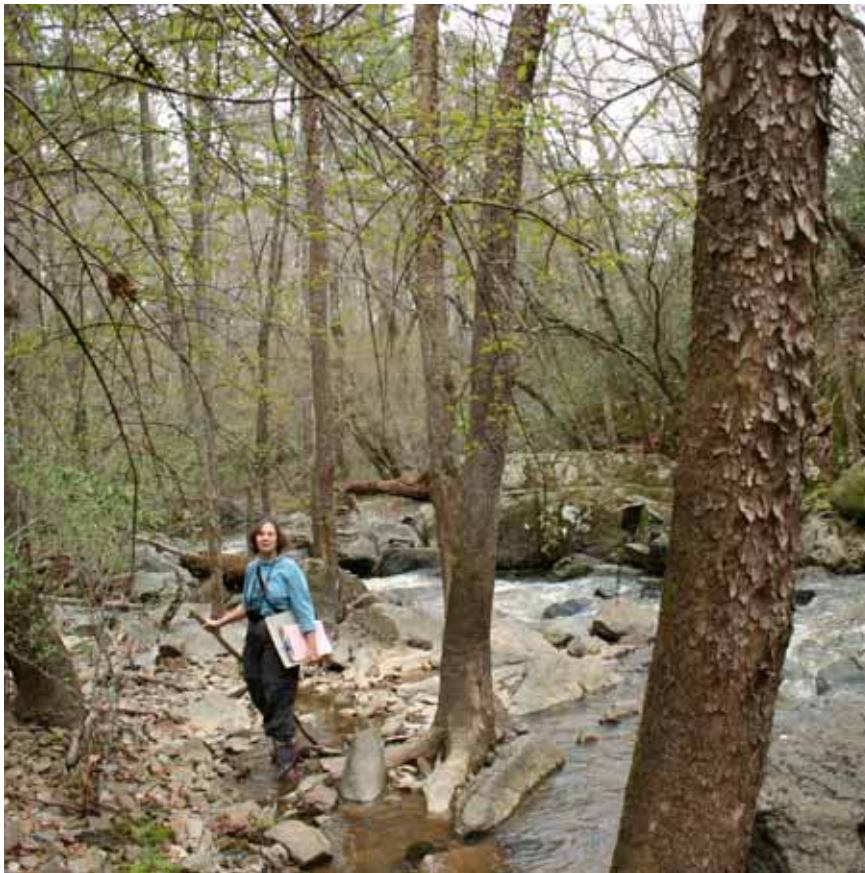
HRA staff, Kathy Buck, assisting in the assessment of Dry Creek in the downstream reaches just before the confluence with the Haw.

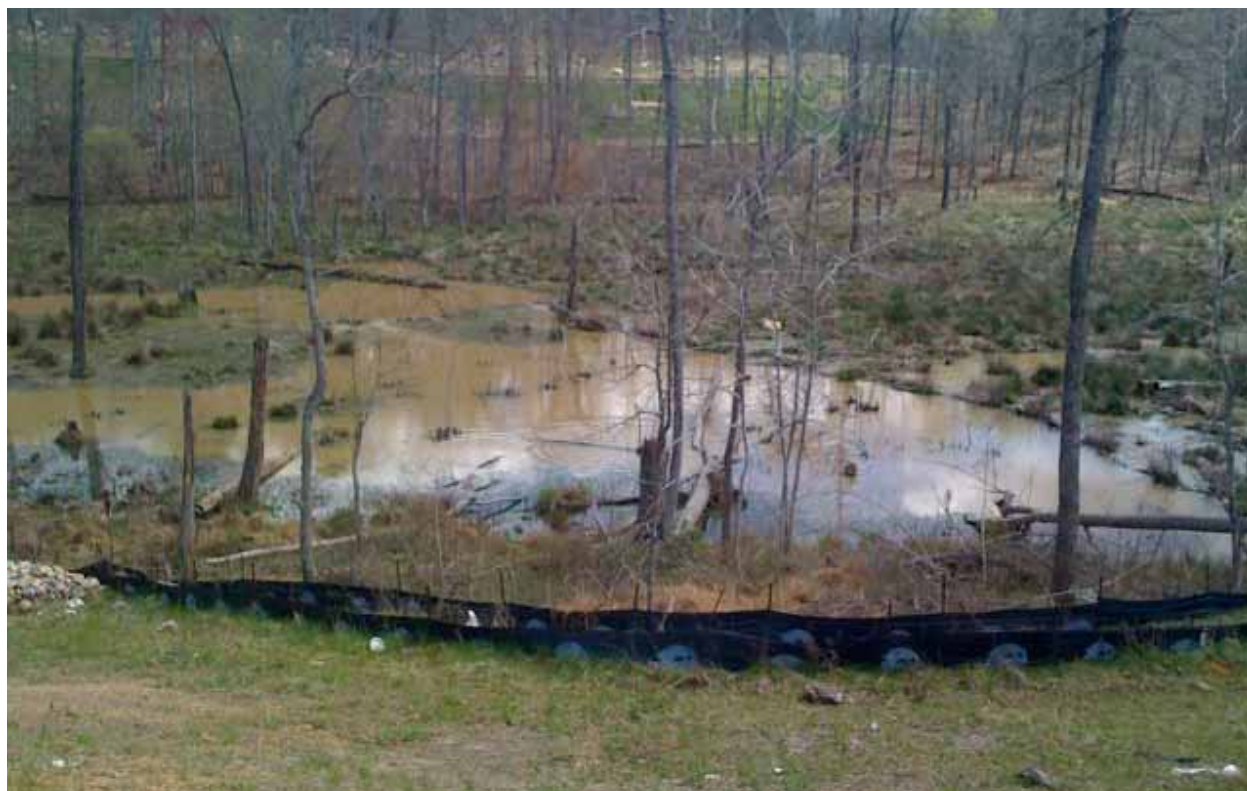
Pokeberry Creek wetland in Briar Chapel continues to be impacted by muddy runoff from upstream logging, from power line easement, and from new construction.

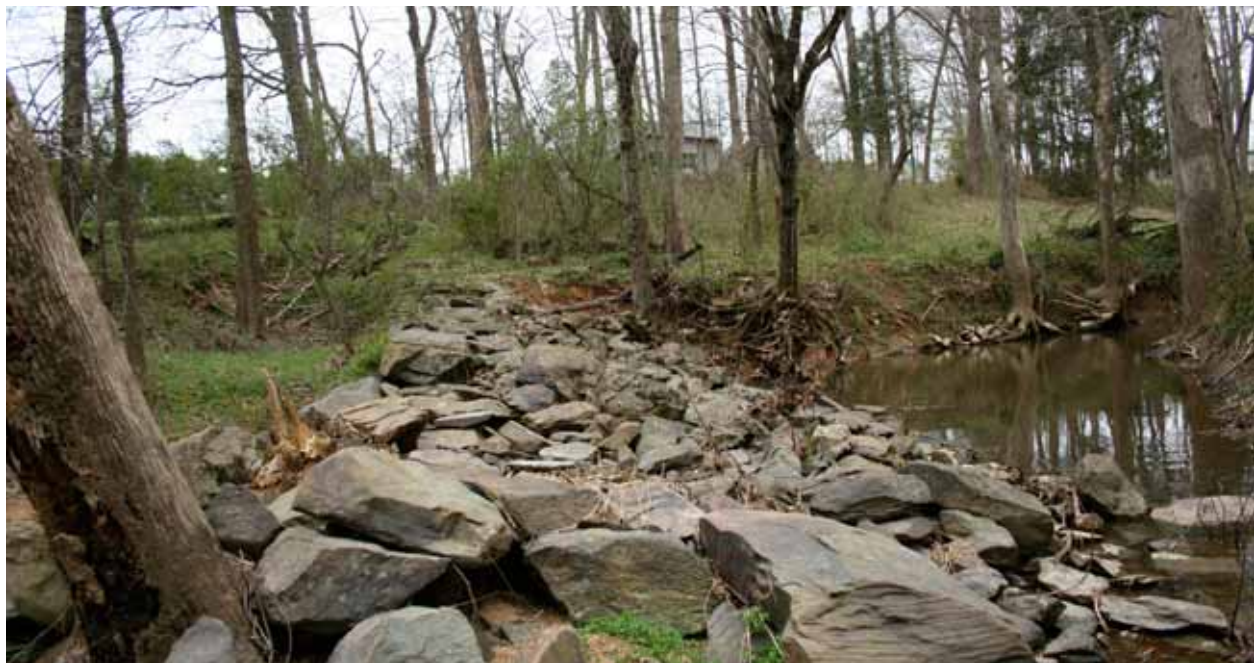
Possible remains of Clarks Mill spanning Dry Creek.

We found land along Dry Creek to be more rural compared to Pokeberry Creek with much timberland and farming. Deeply incised stream channels, divergent channels coupled with the numerous rock walls along the stream banks indicate that Dry Creek has a long history of being affected by rural living. Besides old rock walls we found what appeared to be the remains of old grist mills. The location of some of these remains corresponds to the location of Clarks Mill on Captain Ramsey's 1870 Map of Chatham. This old mill site and other stone crossings over Dry
